RESEARCH, DEVELOPMENT & TECHNOLOGY TRANSFER QUARTERLY PROGRESS REPORT

Wisconsin Department of Transportation
DT1241 02/2011

The objectives of this study are to investigate methods and products that may be used in the aesthetic and protective coating of bridge concrete components and to develop a guideline for cost-effective bridge coating practices for concrete members. A series of concrete coating systems will be identified and tested in the laboratory to evaluate their performance under simulated environmental conditions that are similar to those experienced by bridge components in Wisconsin. Wisconsin bridge sites, where coating failures and problems have occurred, have been visited to identify and evaluate the structural details and other factors that have contributed to such coating failures. Upon completion of the testing and evaluation program, guidelines and specifications language will be developed for selection, application, and maintenance of such coating materials.

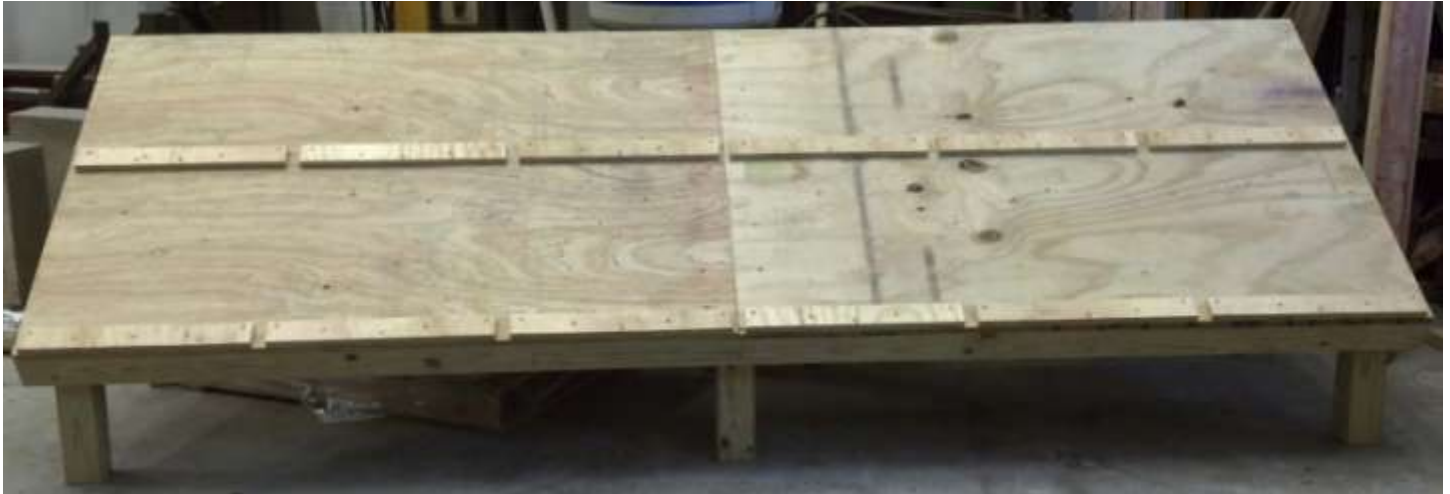
During the curing period the outdoor testing rack was constructed (Figure 1), and an automated spraying system for the sodium chloride solution was developed and constructed.

Figure 1: Outdoor Testing Rack

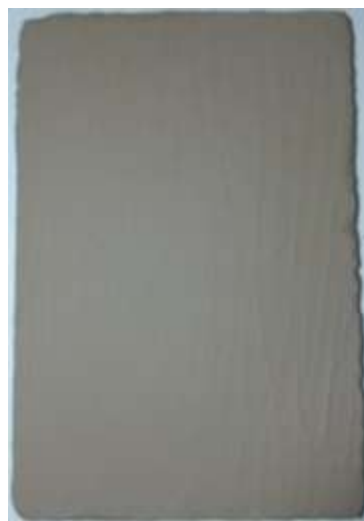
Once the samples were properly cured, application of the coating systems was initiated. However, the heavier coating thicknesses required could not be obtained with a uniform thickness using roller application. The thinning limitations on some of the coatings (specifically Sherwin Williams Ultracrete) prevented the application with available spray equipment. Spray application for all systems was thoroughly explored, but no system was available to apply the high solid content systems with a uniform surface of recommended thickness. Therefore, it has been decided for the systems which allow thinning or have the proper viscosity to use a conventional spray system to achieve a uniform thickness. All other coating systems (2 systems) will be applied by brush/roller in multiple layers to make sure achieving a uniform coating with the recommended thickness. A test sample (Figure 2) with successfully achieving the appropriate coating thickness through using brush/roller application is shown below.

Figure 2: Roller Applied Coating Sample

Extensive efforts and time were needed to determine appropriate means of applying various coating systems with varying viscosity levels (as describes above).
